2011 IBTTA Maintenance Conference, Nashville, October 24th – 26th

Hale Boggs Cable Stayed Bridge – Inspection, Fatigue Analysis & Repair

Paul Norton, PE

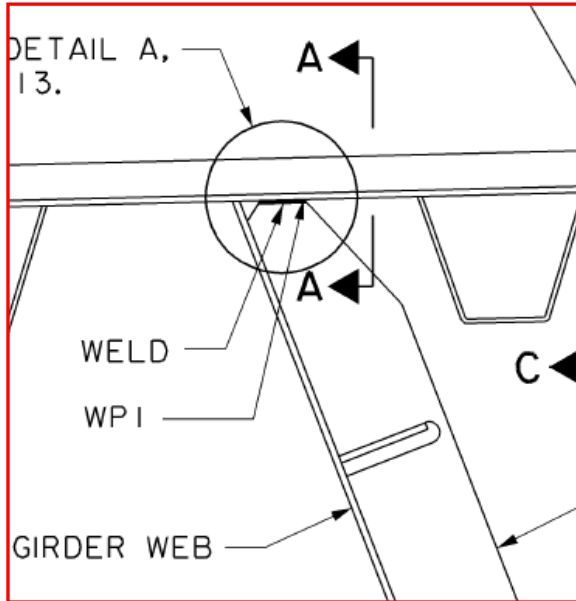
Crack in orthotropic deck plate at end of transverse stiffener weld

Crack

- ☐ 75 Cracks in Orthotropic Deck Plate
- ☐ 37 Cracks in Weld Only

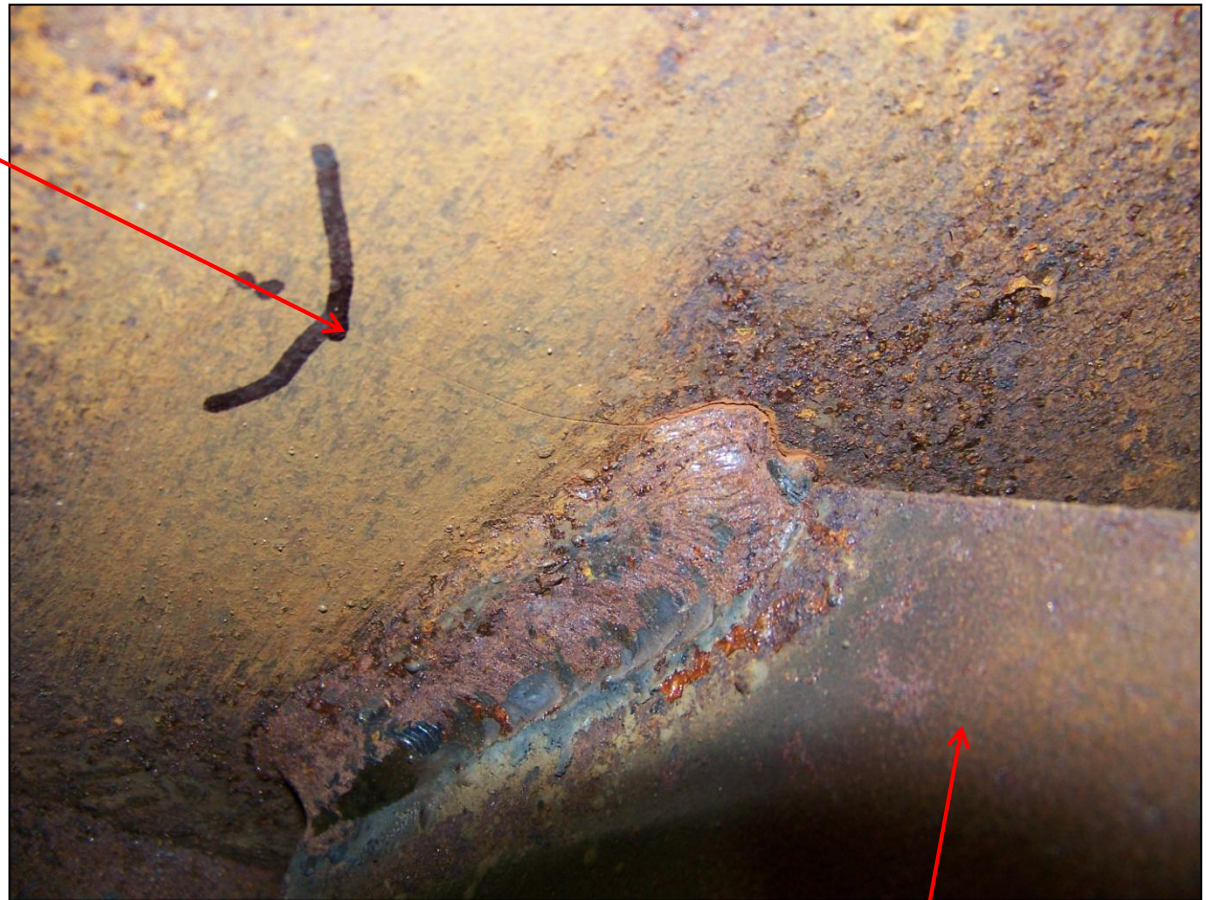
Crack Location

- Cracks occurred in the deck plate and the fillet weld at the connection of the box girder web transverse stiffener to the orthotropic deck (112 cracks out of 800+ total locations).
- Cracks exhibited only in the outboard web of the box girders (under the outside wheel line of traffic in each direction).
- Cracks in other components (lifting lugs & cross girder)

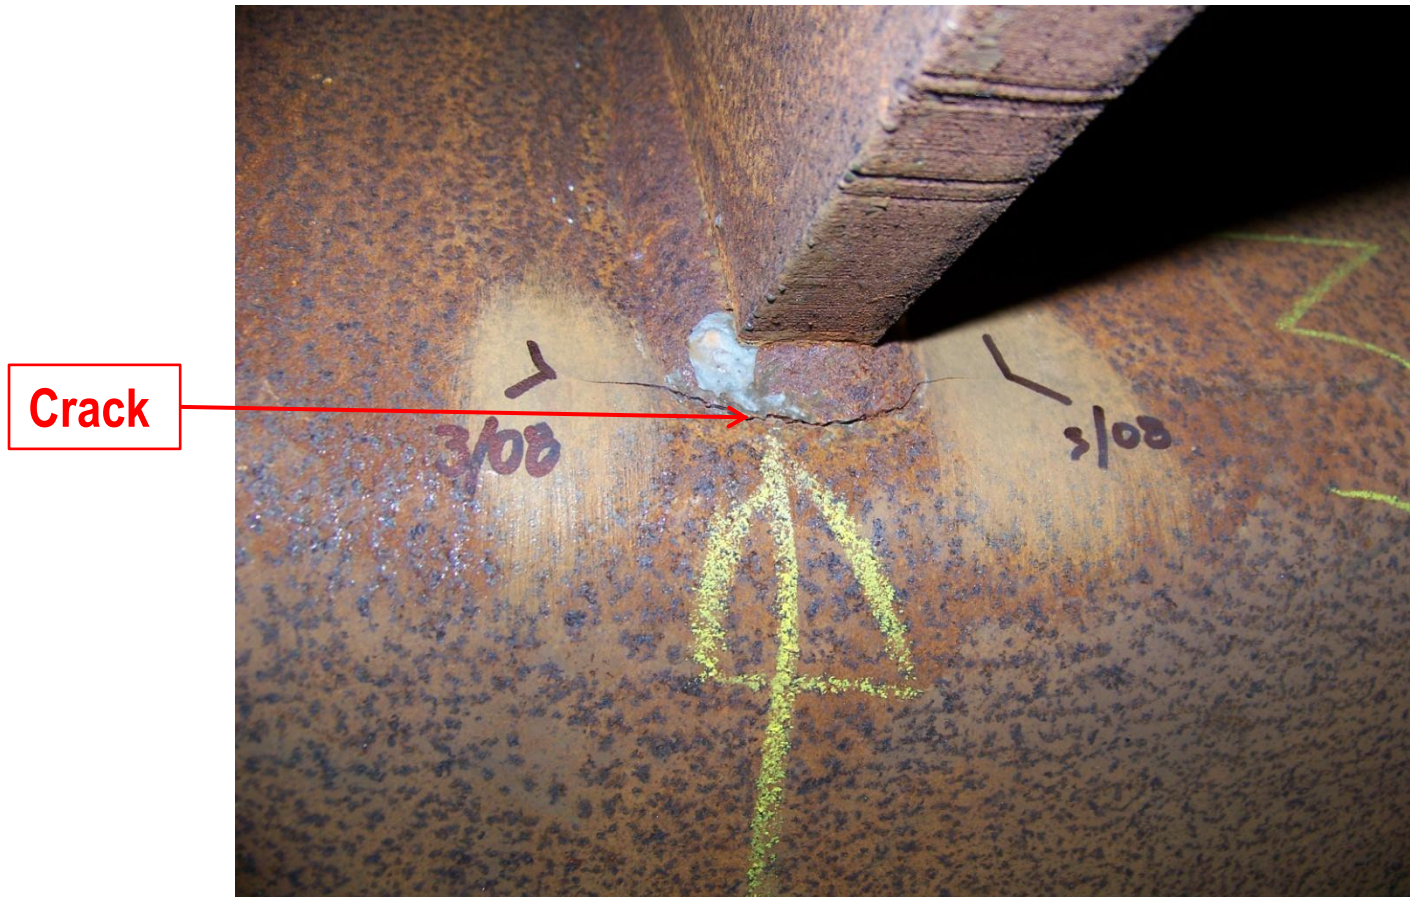
Crack in orthotropic deck rib at Lifting Lug

❑ 13 Cracks in Orthotropic Deck Rib

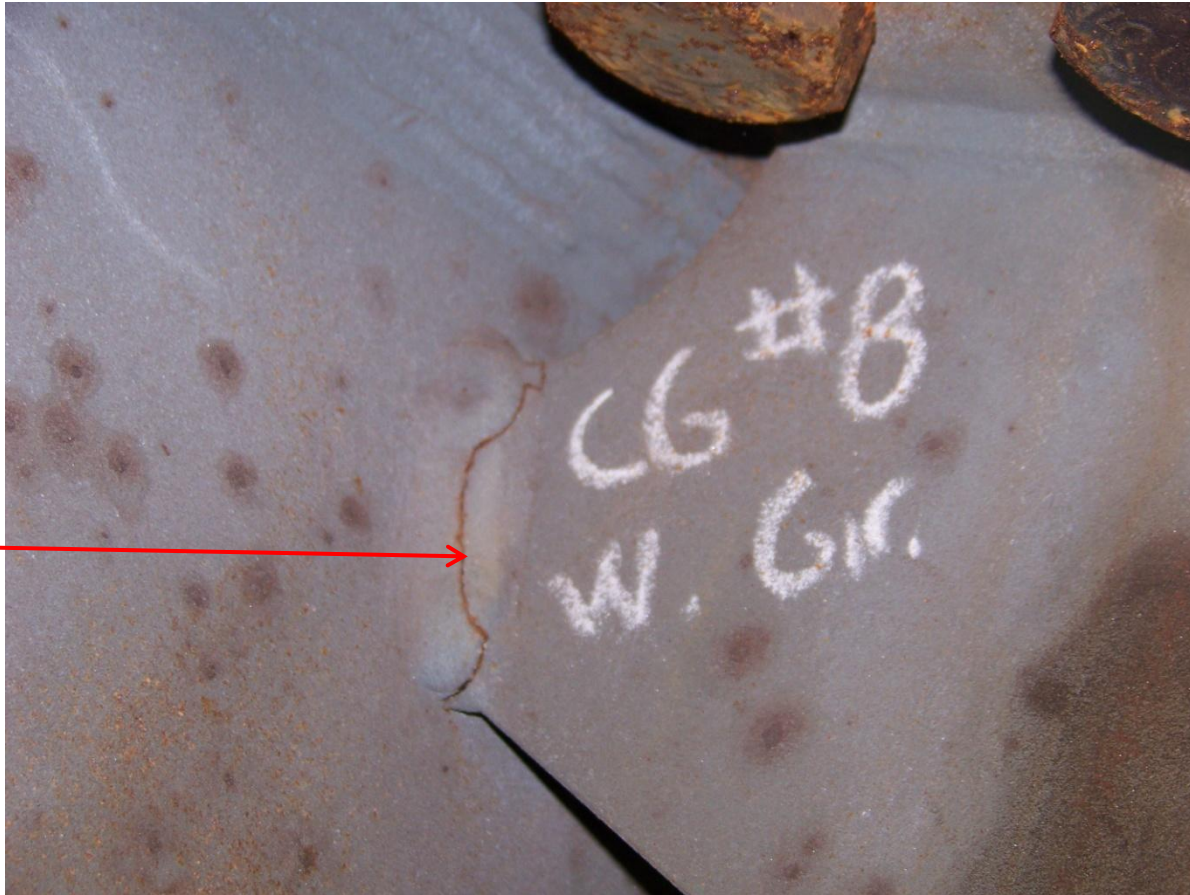
Crack inside cross girder at internal diaphragm

Crack

☐ 3 Cracks in Cross Girders

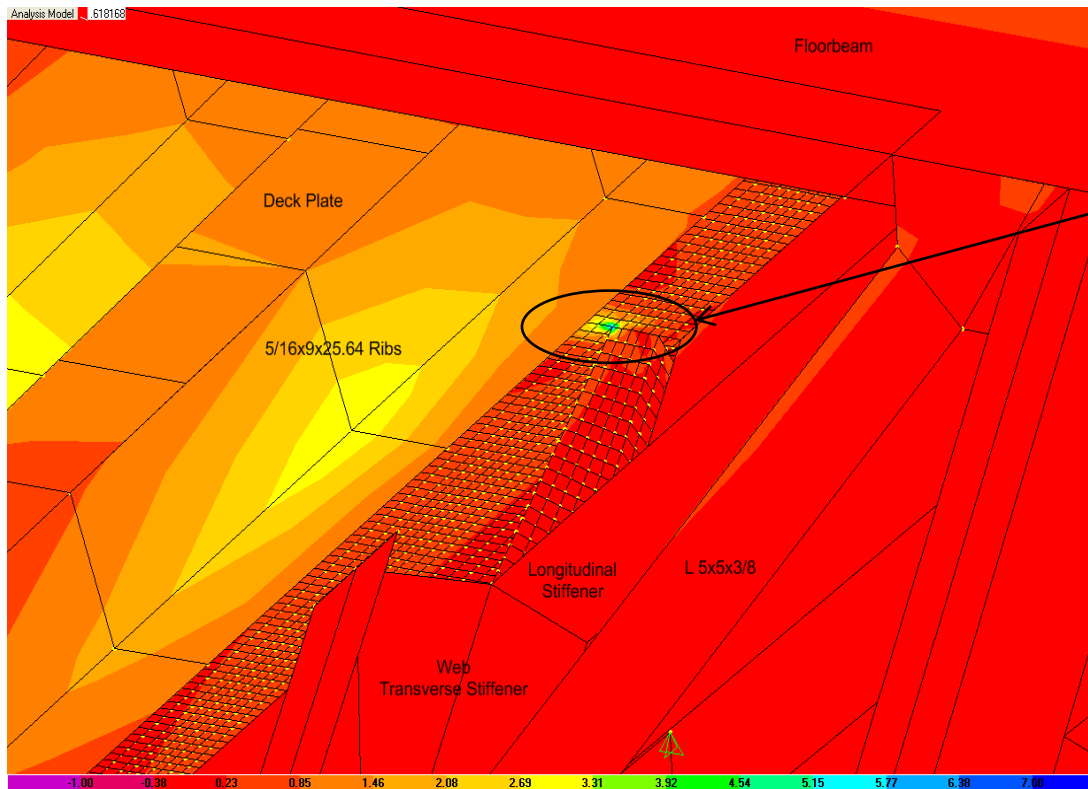
Analytical Results: Outside Lane Loaded

- Concentrated stress at the web transverse stiffener to the deck plate connection (outer web).

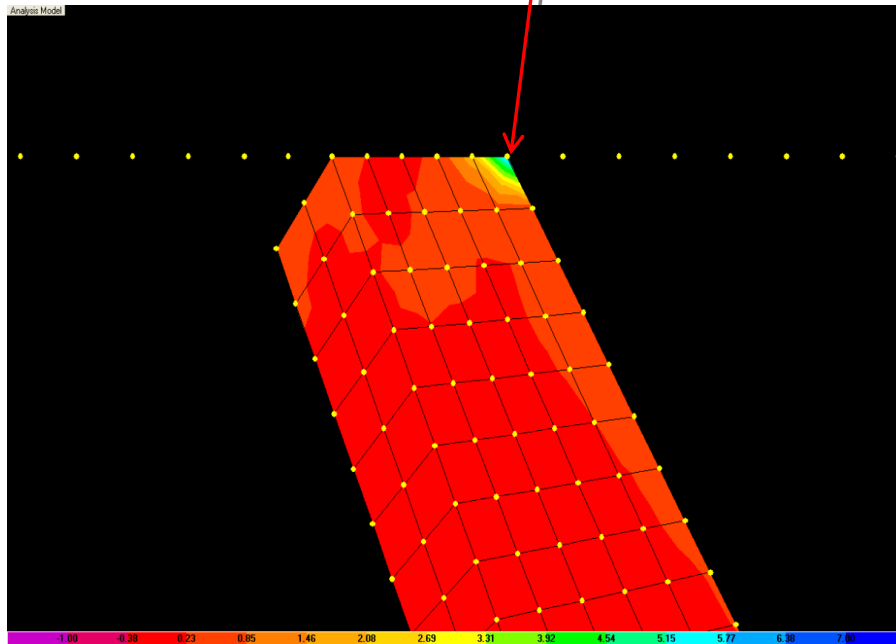
At outer Web

6.6 ksi

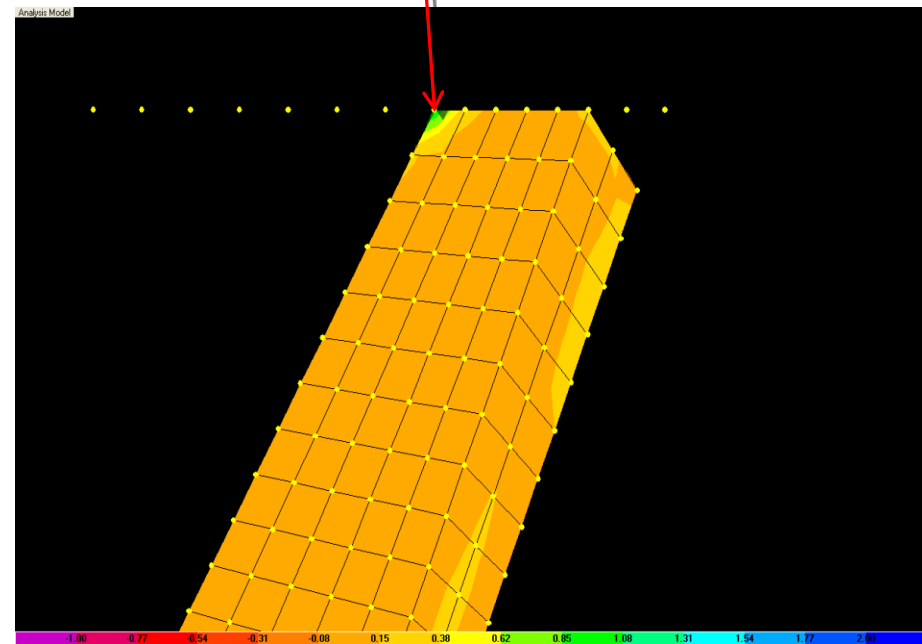
At inner web

1.2 ksi

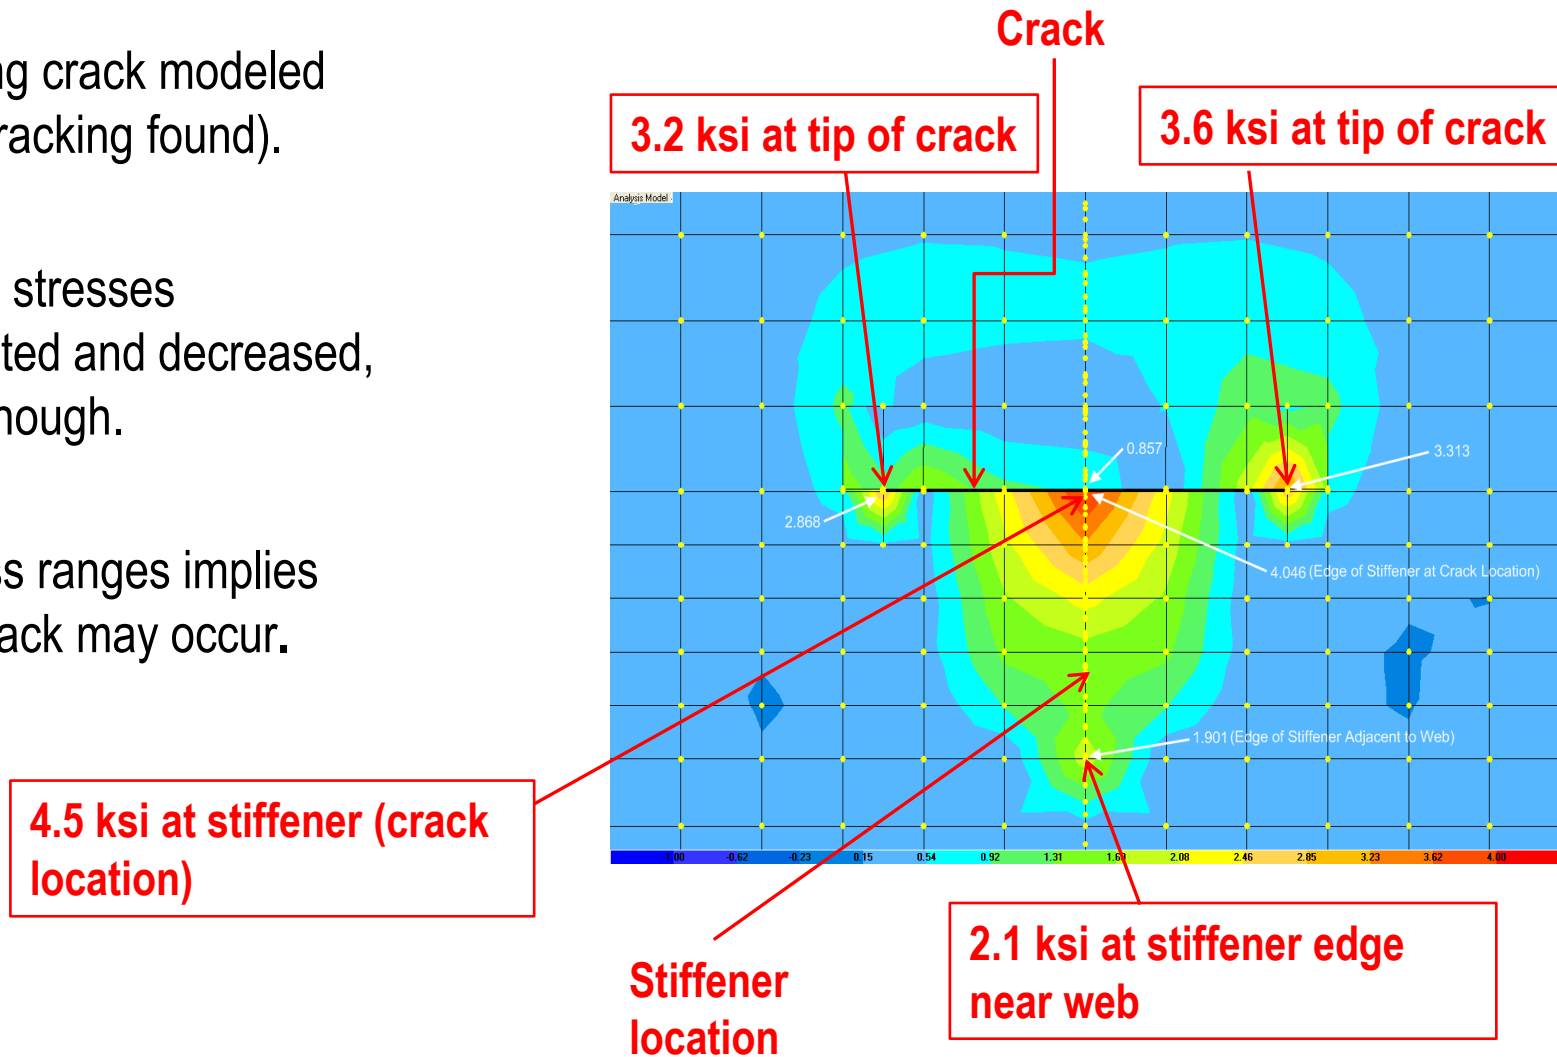
Analytical Results if No Repair Action

- A 5-in long crack modeled (typical cracking found).
- The deck stresses redistributed and decreased, but not enough.
- The stress ranges implies further crack may occur.

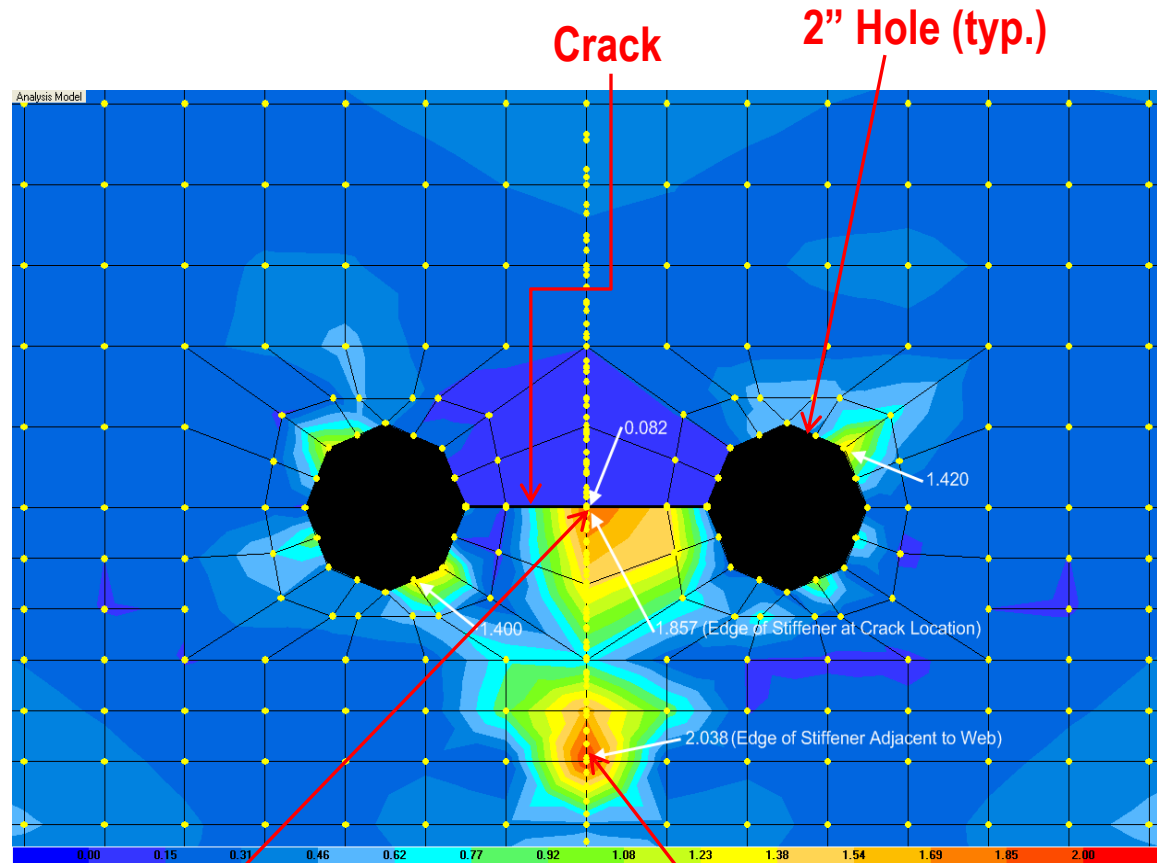
2-in Diameter Arresting Holes

- Two 2-in diameter holes.
- The stress range at crack decreased by 54%.
- All stress ranges less than 4.4 ksi.

2.0 ksi at stiffener (crack location)

2.2 ksi at stiffener edge near web

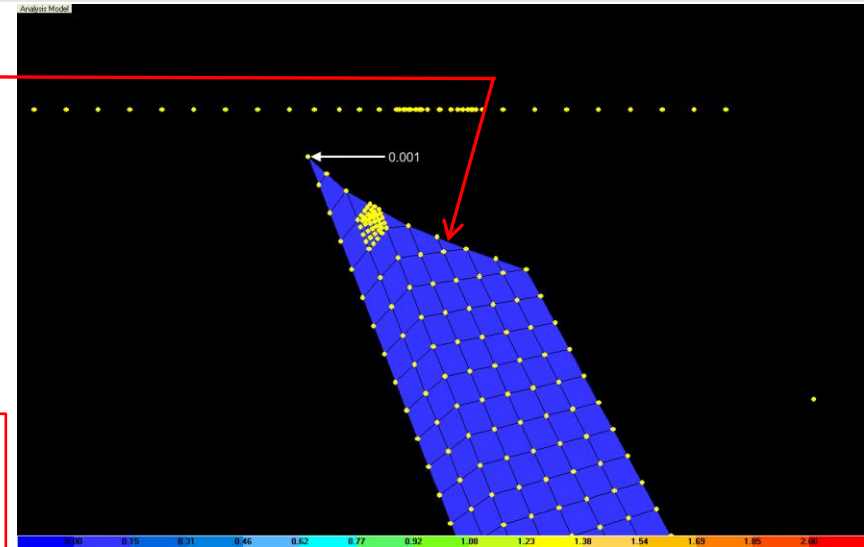
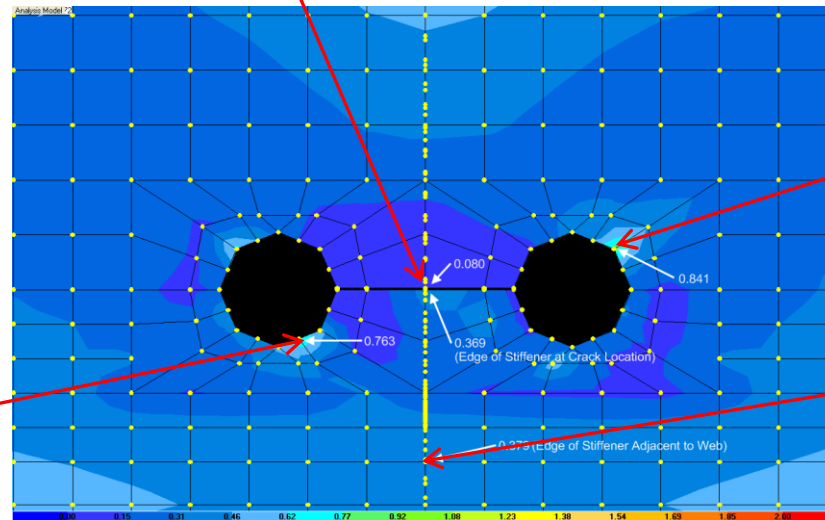
2-in Diameter Arresting Holes and Cutting Web Stiffener

- The web transverse stiffener to deck connection removed.
- The stresses in the deck significantly reduced.

**0.4 ksi at stiffener
(crack location)**

**0.9 ksi at the drilled
hole**

**0.4 ksi at stiffener
edge near web**

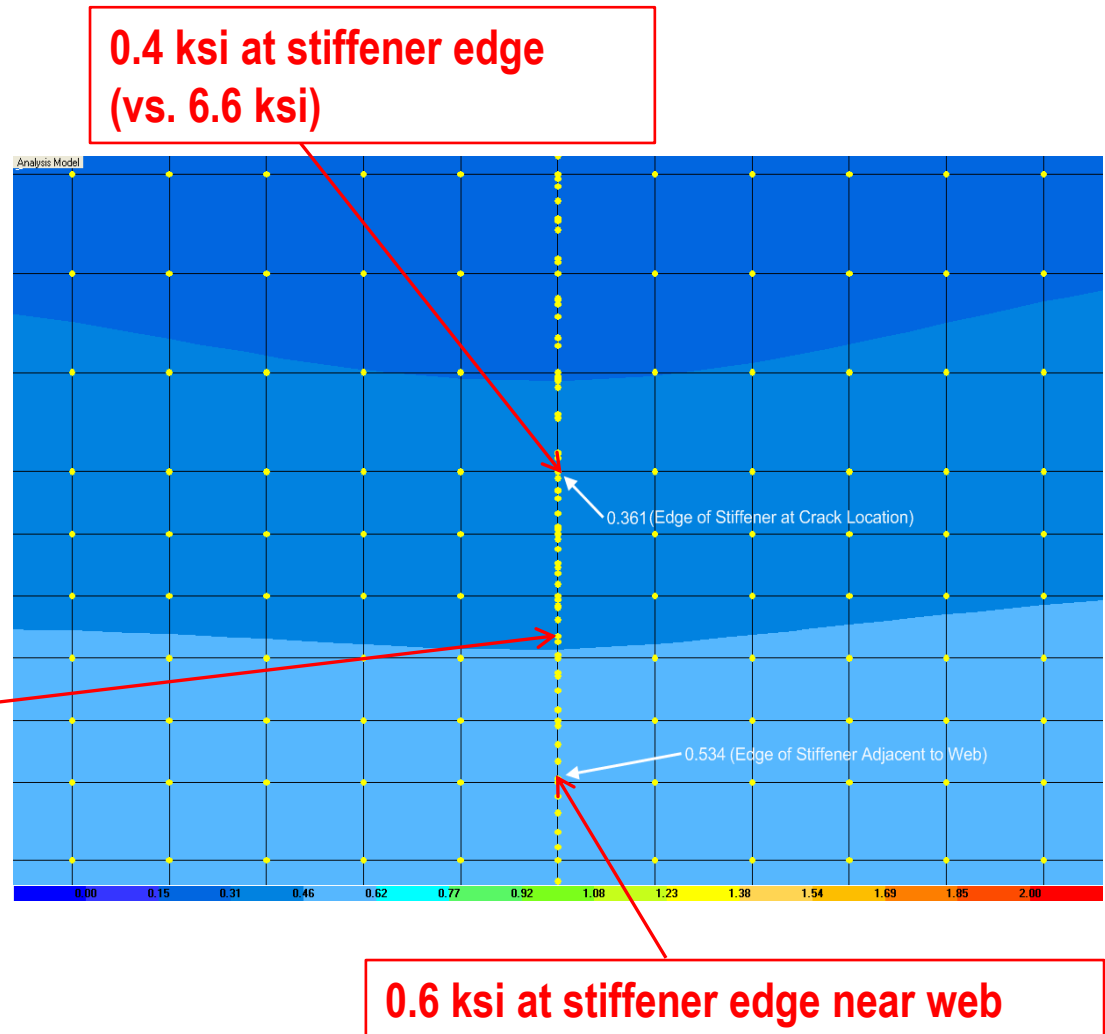
Cutting Web Stiffener at Locations with No Cracking

- The web transverse stiffener to deck connection removed.
- The stresses in the deck significantly reduced.
