EVALUATION OF THE EFFECTIVENESS OF A VARIABLE ADVISORY SPEED SYSTEM ON QUEUE MITIGATION IN WORK ZONES

Utah Department of Transportation
Research Division

Brigham Young University
Department of Civil & Environmental
Engineering

FINAL REPORT

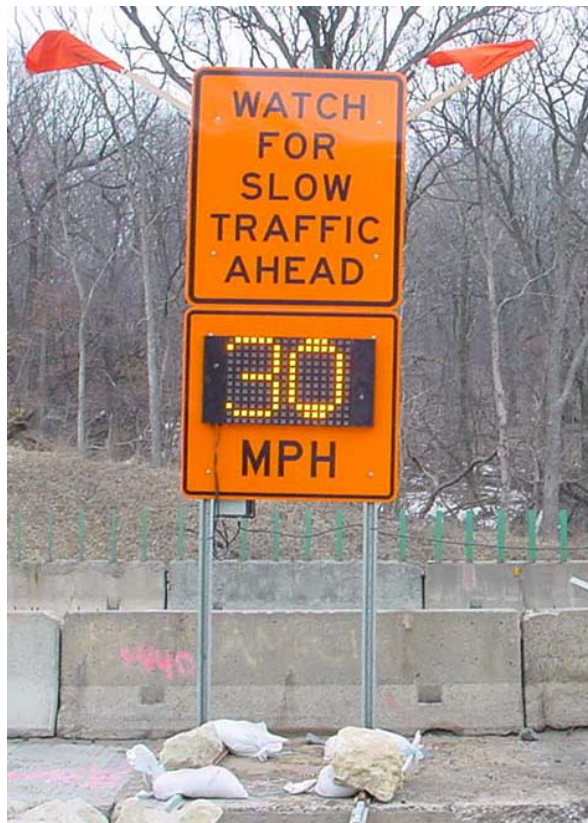
Figure 2-1 Example of variable message sign on study site (Kwon et al. 2007).

Most research found during the literature review was done using a VSL system. Although similar in concept a VSL is more restrictive than the scope of the VASS evaluated in this study. Therefore, this study concludes that minimal research has been done on VASSs used for queue mitigation in work zones. Due to the increasing need to find ways to better control traffic flow in work zones more research was needed on the topic of advisory speeds. This study used a VASS in a work zone entrance to evaluate the effectiveness of the VASS at mitigating queues. A similar study was done using the resemblance of advisory speeds (See Figure 2-1) by Kwon et al. (2007). The use of orange signs instead of white was a step in the right direction. More specific direction on the fact that the speed was advisory would be helpful for drivers. Therefore, in this study on VASSs VMSs will give the drivers the advisory speed for approaching the work zone entrance.

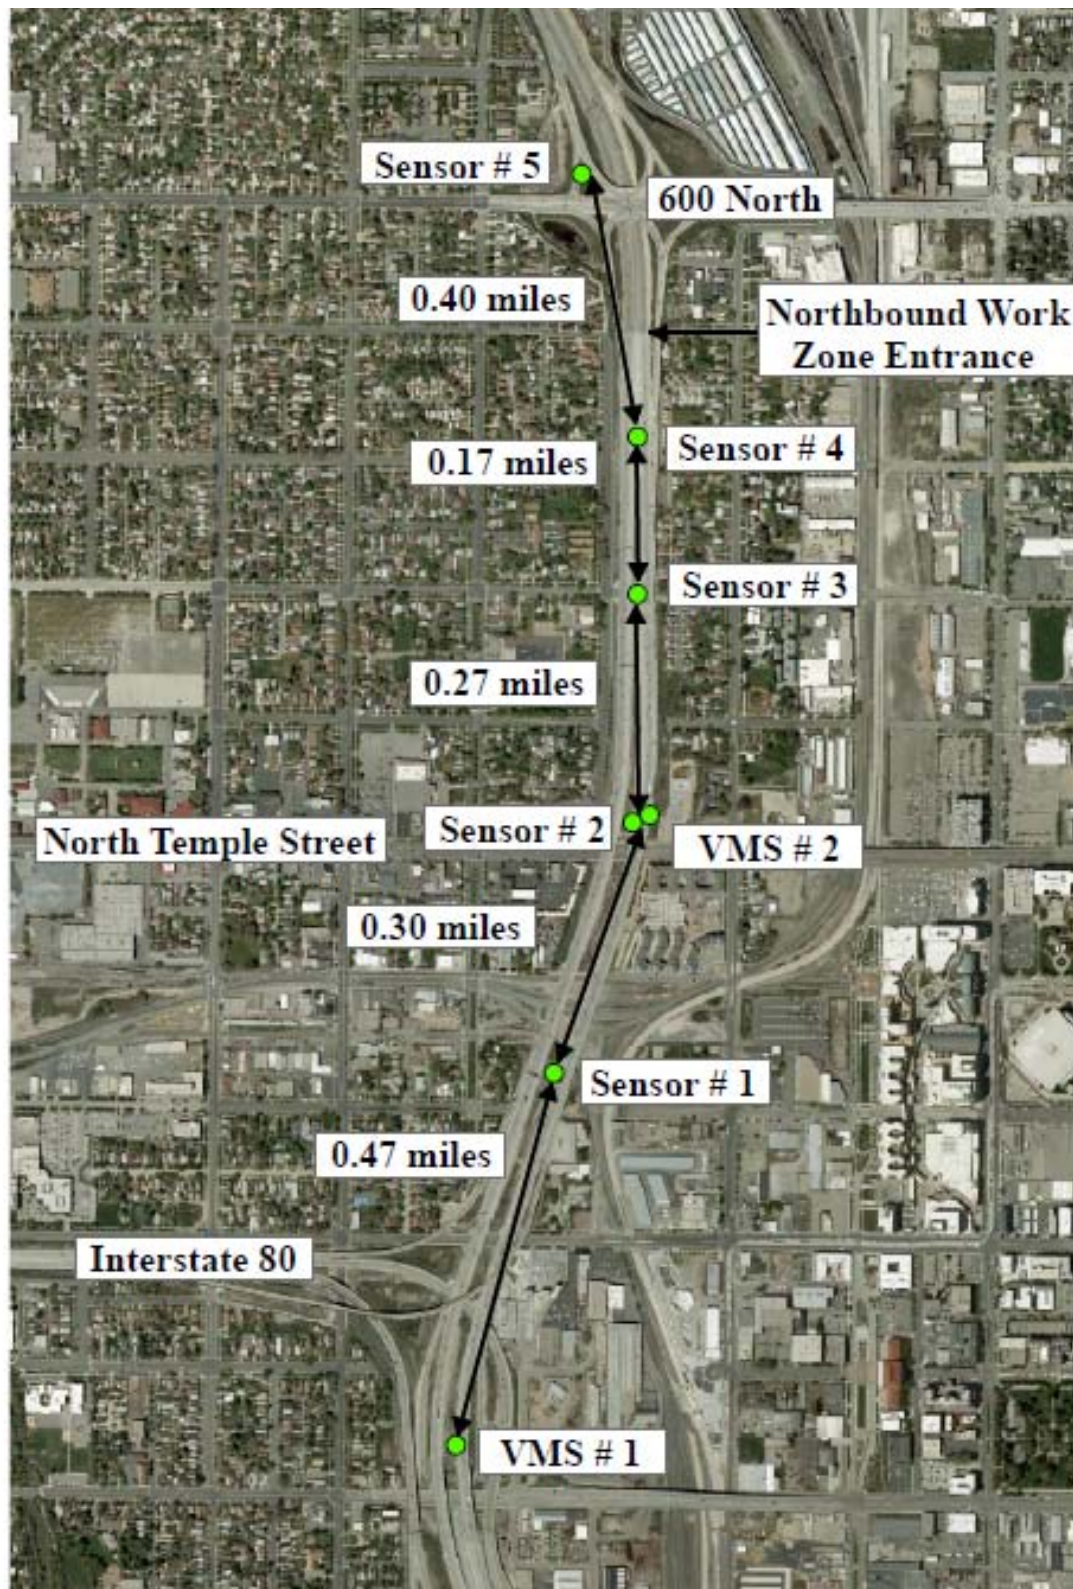
Figure 3-1 Sensor locations (background image by AGRC 2011).

During the site visit on February 23, 2010, general areas were outlined and specific locations for the sensors and VMSs were selected. The layout found in Figure 3-1 was then updated to reflect the actual locations where sensors or VMS boards would be placed. In addition to designating the location of sensors and VMSs the specific locations were painted so it would be easy to know where to place the sensors and VMSs at the time of deployment. All locations for VMSs and Sensors were then approved by UDOTs Resident Engineer for the project as well as the other technical advisory committee (TAC) members prior to deployment.

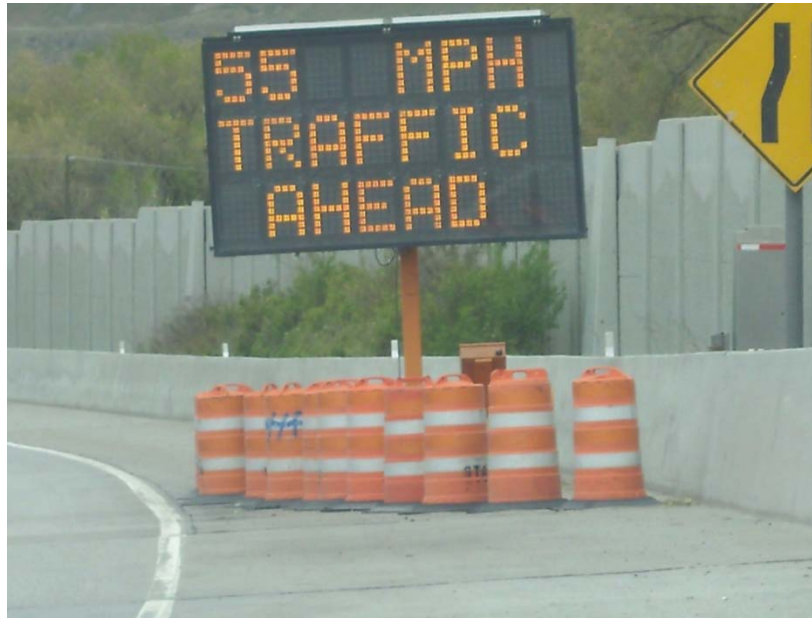
Figure 3-8 VMS 2 final location (taken by Aaron Wilson).

successful enough to allow the use of UDOT's VMS. This was the last issue to resolve. As a result of this issue VMS 2 was placed on the right shoulder just north of sensor 2, with barrels to protect it. Figure 3-8 shows VMS 2 in its final location with barrels to protect it on the east side of I-15 just north of the bridge over North Temple St.

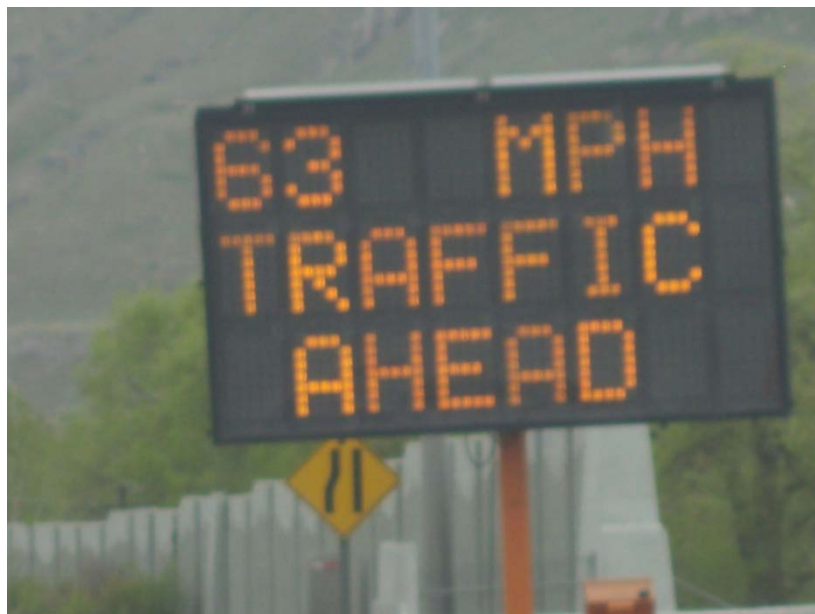
Figure 3-9 First message displayed on VMS 2 (taken by Aaron Wilson).

Although it was anticipated that the system would be functioning correctly from day one it was quickly determined that there were a couple of things that were not properly communicated to ASTI. The VMS began with a display of “63 MPH TRAFFIC AHEAD,” as

shown in Figure 3-9. The issue here was that UDOT and BYU anticipated the speed would be displayed in 5 MPH increments, and when speeds in excess of 55 MPH were seen, at the sensors, the VMS would only show “55 MPH TRAFFIC AHEAD” so as to not encourage drivers to go faster than the posted speed limit. During the time ASTI turned on the message boards one member of the BYU team was in communication with ASTI at the study site. The problem of showing speeds above 55 mph was quickly resolved while it took a few hours before the system was set up, as originally planned, to show only 5 mph increments. Figure 3-10 shows VMS 1 after the problems were fixed and the correct messages were being displayed.
