2011 IBTTA Maintenance Conference, Nashville, October 24th – 26th

Hale Boggs Cable Stayed Bridge – Inspection, Fatigue Analysis & Repair

Paul Norton, PE

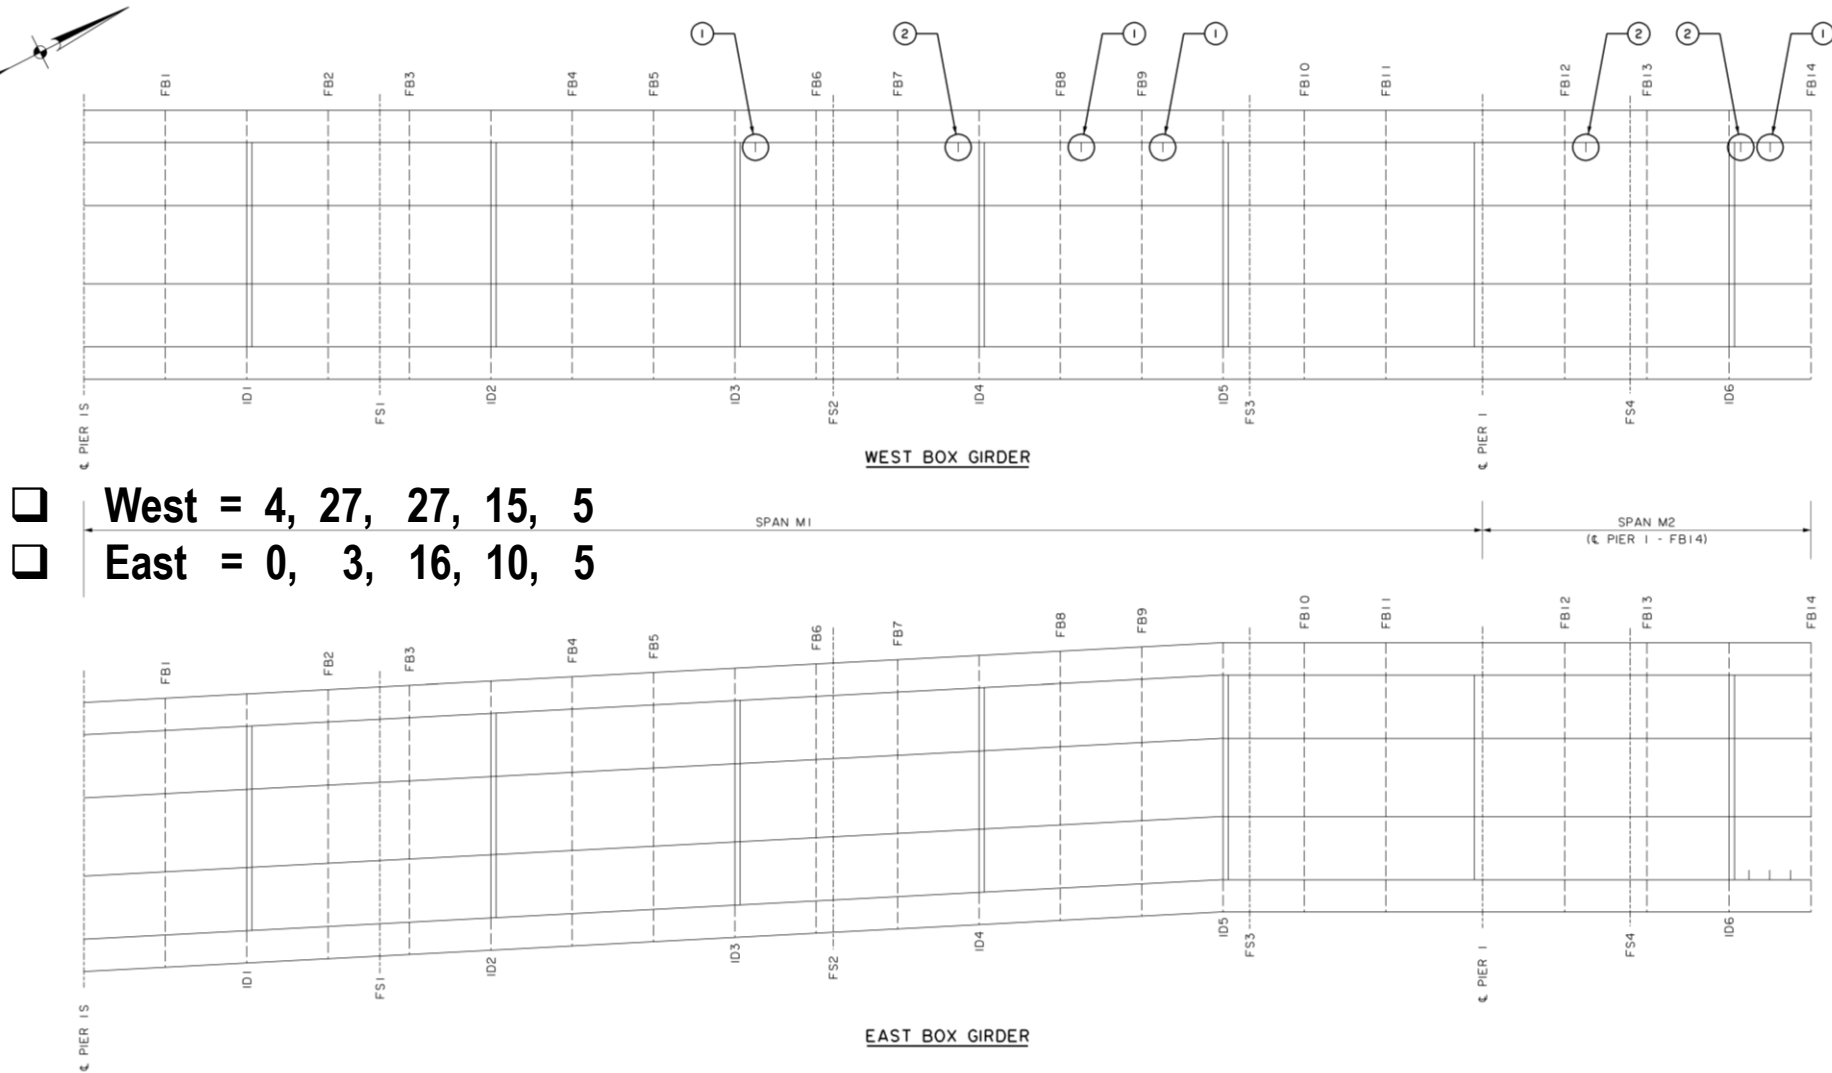
Crack Locations

- Cracks occurred in the deck plate and the fillet weld at the connection of the box girder web transverse stiffener to the orthotropic deck (112 cracks out of 800+ total locations).
- Cracks exhibited only in the outboard web of the box girders (under the outside wheel line of traffic in each direction).
- Cracks in other components (lifting lugs & cross girder)

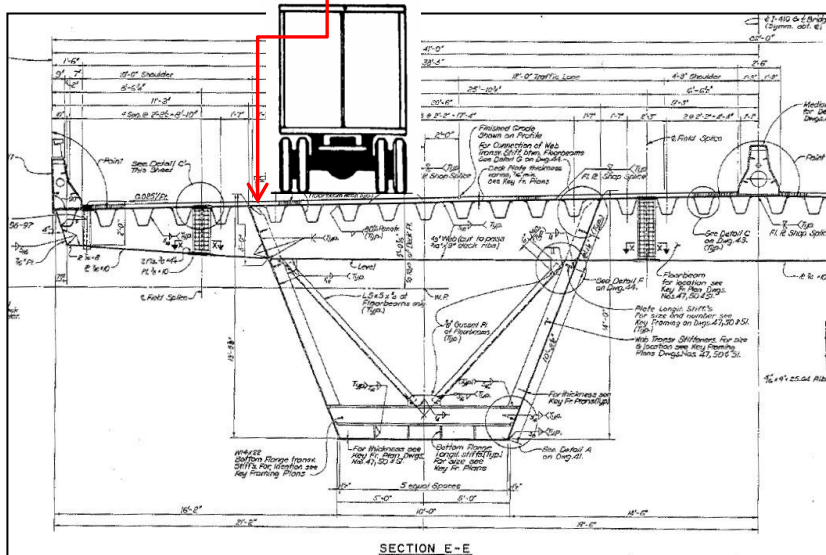
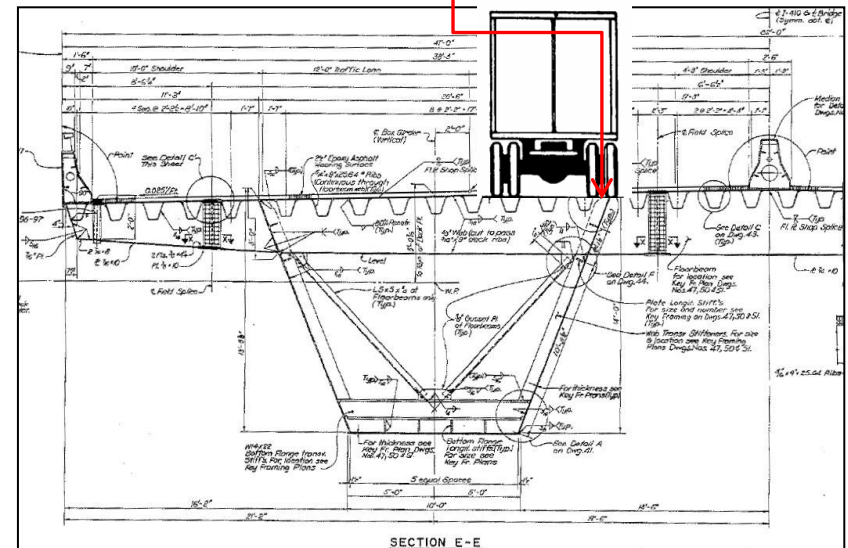
Table 1 – Fatigue Stress Ranges in Deck Plates Along Outer Web of Box Girder

Location	Outside Web	AASHTO Limiting Stress Range (Cat. C)
	(Axial, ksi)	(ksi)
At Web Stiffener	6.635	4.4
At Non Web Stiffener	0.099	4.4

Table 2 – Fatigue Stress Ranges in Deck Plates Along Inner Web of Box Girder

Location	Inner Web	AASHTO Limiting Stress Range (Cat. C)
	(Axial, ksi)	(ksi)
At Web Stiffener	1.188	4.4
At Non Web Stiffener	0.058	4.4

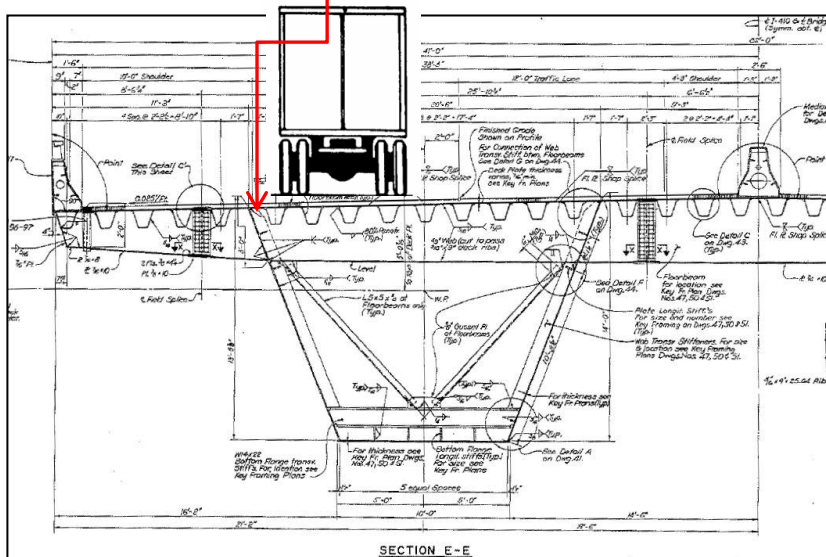
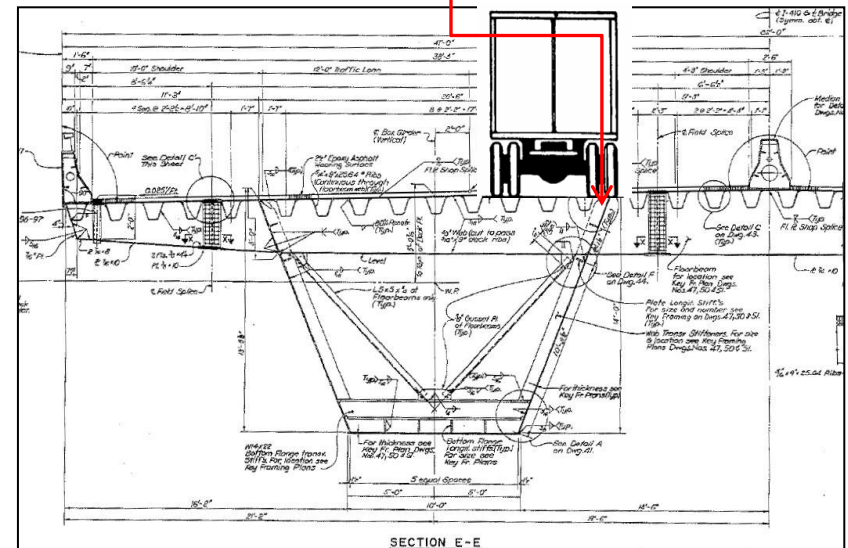
Fatigue Stress Ranges in Web Stiffeners

Table 3 – Fatigue Stress Ranges in Web Transverse Stiffener to Deck Connection at Outer Web

Location	Outside Web	AASHTO Limiting Stress Range (Cat. C)
	(Vertical, ksi)	(ksi)
Corner at Crack	6.635	4.4
Corner Closer to Box Girder Web	0.337	4.4

Table 4 – Fatigue Stress Ranges in Web Transverse Stiffener to Deck Connection at Inner Web

Location	Inside Web	AASHTO Limiting Stress Range (Cat. C)
	(Vertical, ksi)	(ksi)
Corner at Crack	1.188	4.4
Corner Closer to Box Girder Web	0.203	4.4
